**WESTFIELD BUSINESS PARK WATER MAIN INVESTIGATION,
ELGIN, ILLINOIS**

Client: City of Elgin

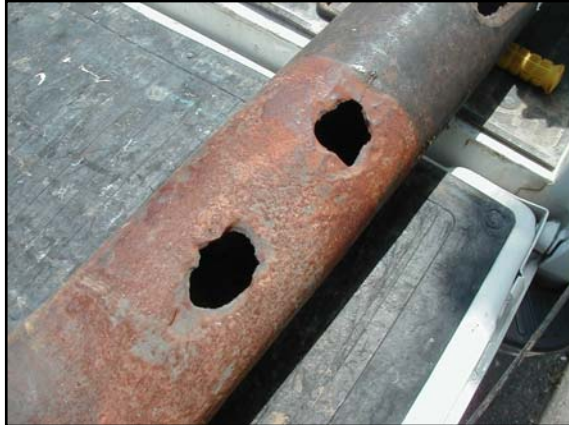
The City of Elgin became concerned when a water break was reported on the 15-year old ductile iron pipe. When they excavated the pipe they discovered that a six foot long piece had corroded to the point of looking much like the photo above. A procedure including both in-field and laboratory testing was followed to determine where conditions were most conducive to corrosion of the ductile iron pipe. Soil borings were drilled in 23 locations to obtain soil samples along the existing watermain. Laboratory testing included classifying the soil types and calculating the moisture content of the samples. Field soil resistivity testing was performed in 15 locations to determine the potential corrosive effects on the pipe material. From this information four locations were determined to best represent potential locations where pipe corrosion may have occurred.

In the future, these locations will be excavated and the pipe will be checked visually for signs of pitting and corrosive damage. Bolts at joints will also be checked. The thickness of the pipe will also be checked using an ultrasonic thickness gauge. The estimated thickness of the pipe in the existing condition will be compared to the thickness of a new pipe of the same pipe class.
